SONIC PULSE VELOCITY TESTING TO ASSESS CONDITION OF A CONCRETE DAM

*Edward D. Billington, AG&E-Schnabel, Greensboro, NC
Dennis A. Sack and Larry D. Olson, Olson Engineering Inc., Wheat Ridge, CO*

Abstract

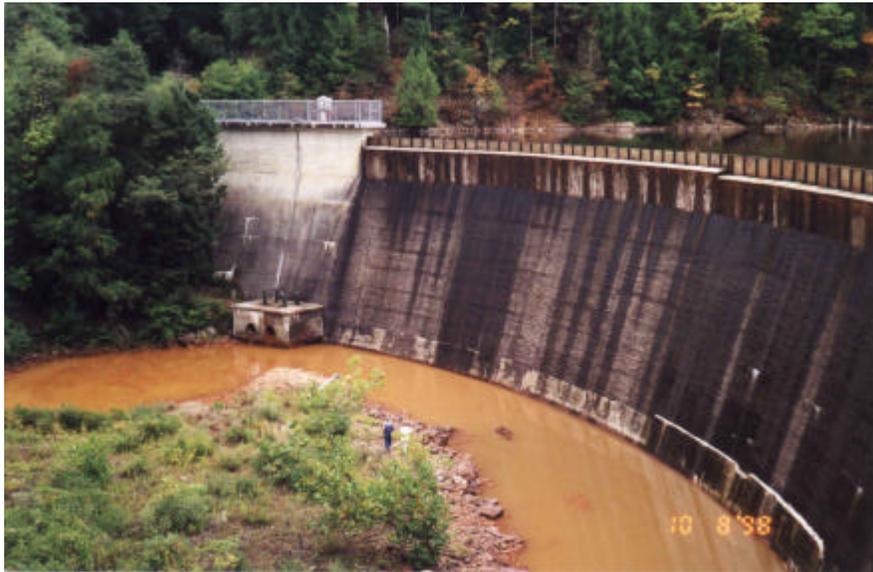
A storm of record in August 1940 overtopped the dam and resulted in significant scour at the toe of the dam. Holes were eroded in the concrete in the dam face and in the concrete splash apron. The holes were patched with concrete. Around 1986, the lake water level was very low, allowing inspection

of the upstream face. A number of open vertical and horizontal joints and some honeycombed areas were patched with epoxy mortar at that time. These open joints may have been related to some seepage on the downstream face.

Figure 1. Lake Logan Dam (view from left abutment)

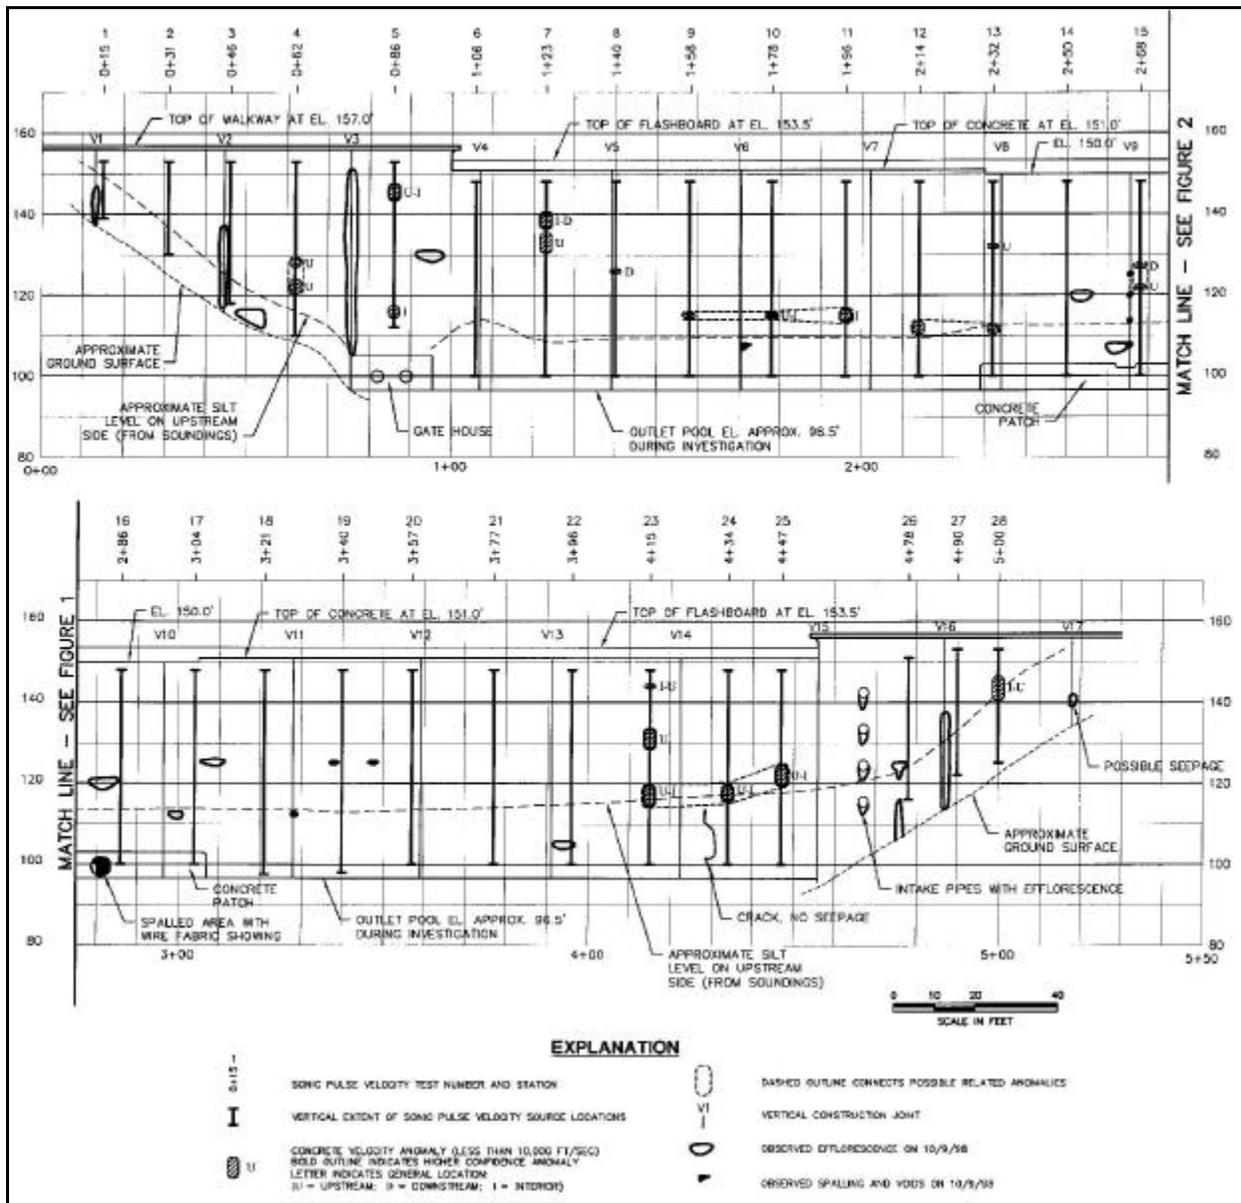
The condition of the concrete on the downstream face of the dam was observed on October 9, to note the location of efflorescence and spalling of the concrete (Figure 6). Most of the efflorescence appeared to be related to vertical and horizontal construction joints. Comparison of the concrete velocity anomalies with the approximate location of efflorescence does not show any obvious correlations, suggesting that the condition causing the efflorescence has not affected the strength of the concrete.

Figure 6. Schematic elevation of dam (looking upstream) showing location of 1998 sonic tests, anomalous velocity areas, and visual observations.

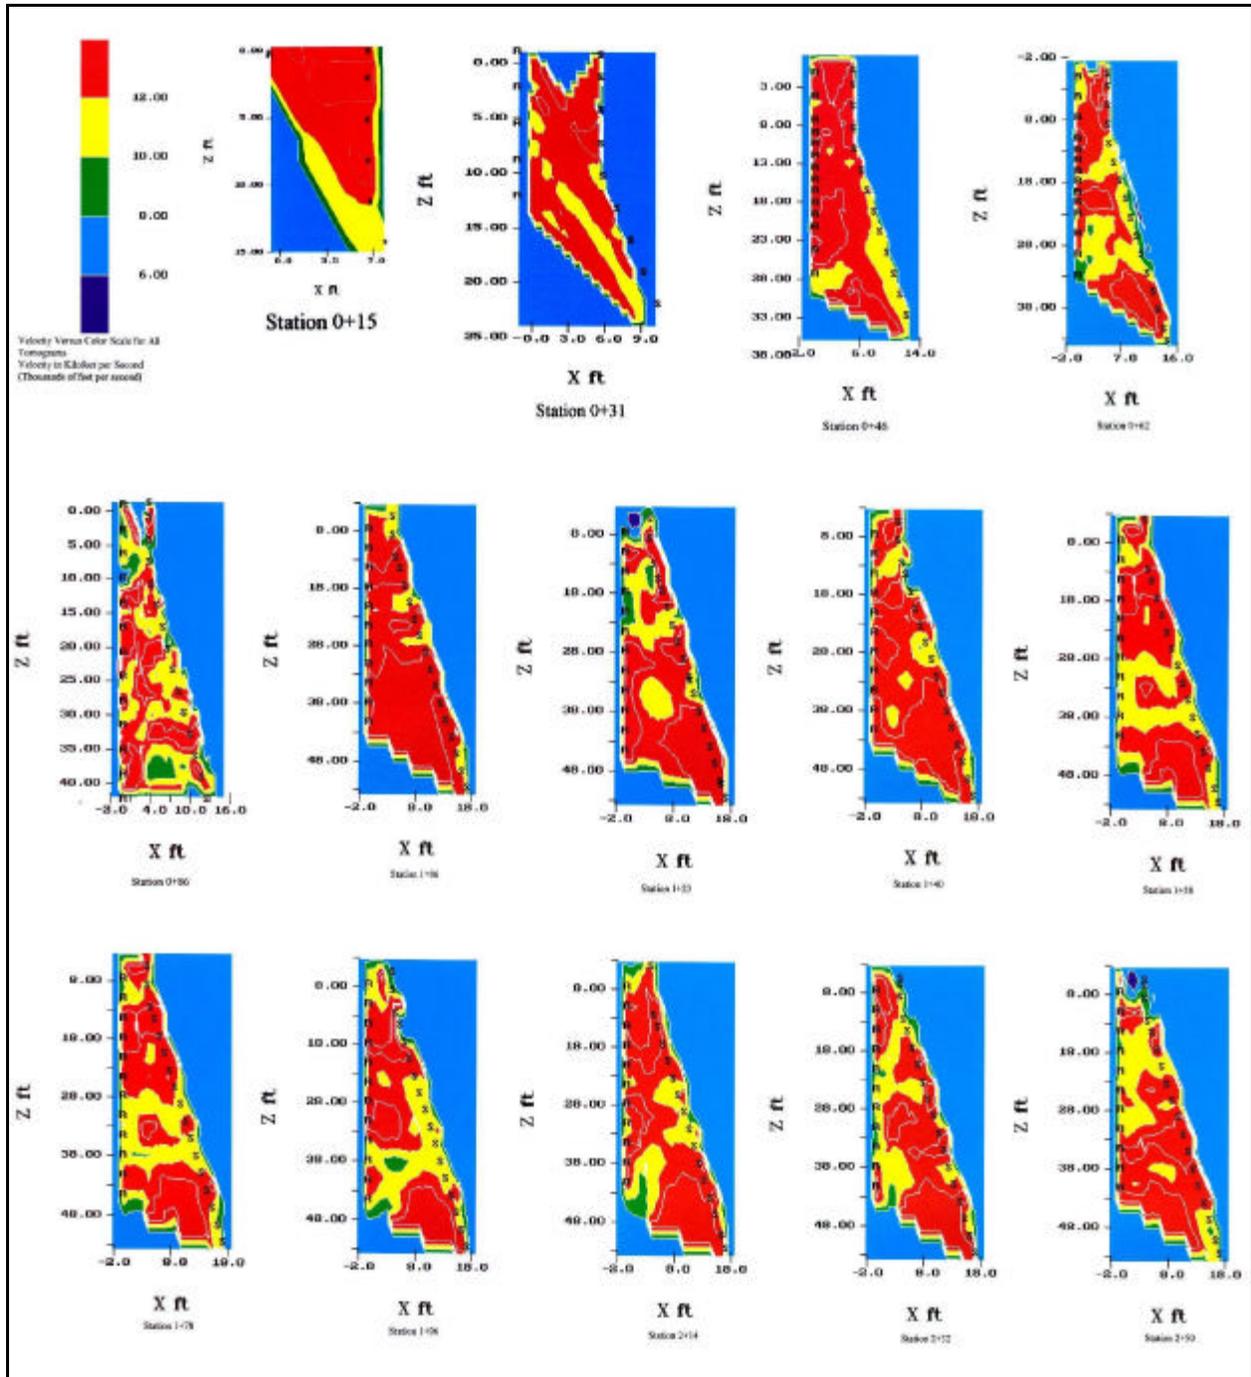
The tomograms show the majority of the concrete to have a velocity between 12,000 and 15,000 fps, indicative of good quality concrete. Some of the low velocity zones are near the edges of the test area, specifically, at or near the upstream and downstream faces and near the bottom of the dam. These areas are of low confidence and may not represent actual velocities and conditions. Low velocity zones

Higher confidence velocity anomalies are located at Stations 0+86, 1+23, 1+78, 1+96, 4+15, 4+34, and 4+47. These anomalies may represent partially open construction joints, cracking, or weaker areas in the concrete. Each anomaly is discussed below. The range in feet given for each anomaly is based on project elevation, relative to the top of the flashboards at project elevation 153.5 feet.

Station 0+86: This station is located above the center of the gate house, as shown on Figure 1. The tomogram for this station shows two low velocity anomalies. The anomaly from elevation 143.5 to 147.5 feet extends from the upstream side of the dam to the center of the dam. The anomaly from elevation 120.5 to 124 feet is in the interior of the dam directly above the gate house but is considered lower confidence due to the small number of raypaths through this area.

Station 1+23: The tomogram for this station shows an anomaly from elevation 143.5 to 147.5 feet between the center of the dam and the downstream face. The vertical orientation of this anomaly is suggestive of a vertical joint, crack, or weak zone. A low confidence anomaly is also noted from about elevation 130.5 to 135.5 feet near the upstream face.

Stations 1+78 and 1+96: A small, apparently horizontal anomaly at Station 1+78 at elevation 115.5 feet correlates with a larger anomaly at the same elevation at Station 1+96. In addition, the tomogram at Station 1+58 shows a velocity distribution that is very similar to that at Station 1+78, including a zone of lower velocity centered at elevation 115.5 feet. The alignment of these anomalies suggests a partially open, horizontal construction joint that is widest at Station 1+96 and becomes thinnest at Station 1+58. The lack of any efflorescence on the downstream face at this elevation indicates that if the anomaly is due to an open joint, it is not open through the dam.

Figure 7. Tomograms for Stations 0+15 through 2+50

Intrusive investigations could be conducted to determine if any open joints, open cracks, or honeycombing is present within the dam. However, since recent dam safety inspections concurrent with the 1998 velocity tests indicate that the dam is safe, there is no need for intrusive investigations at this time. The upstream face should be monitored periodically by divers and/or visual inspections to assess the condition of the joint filler.

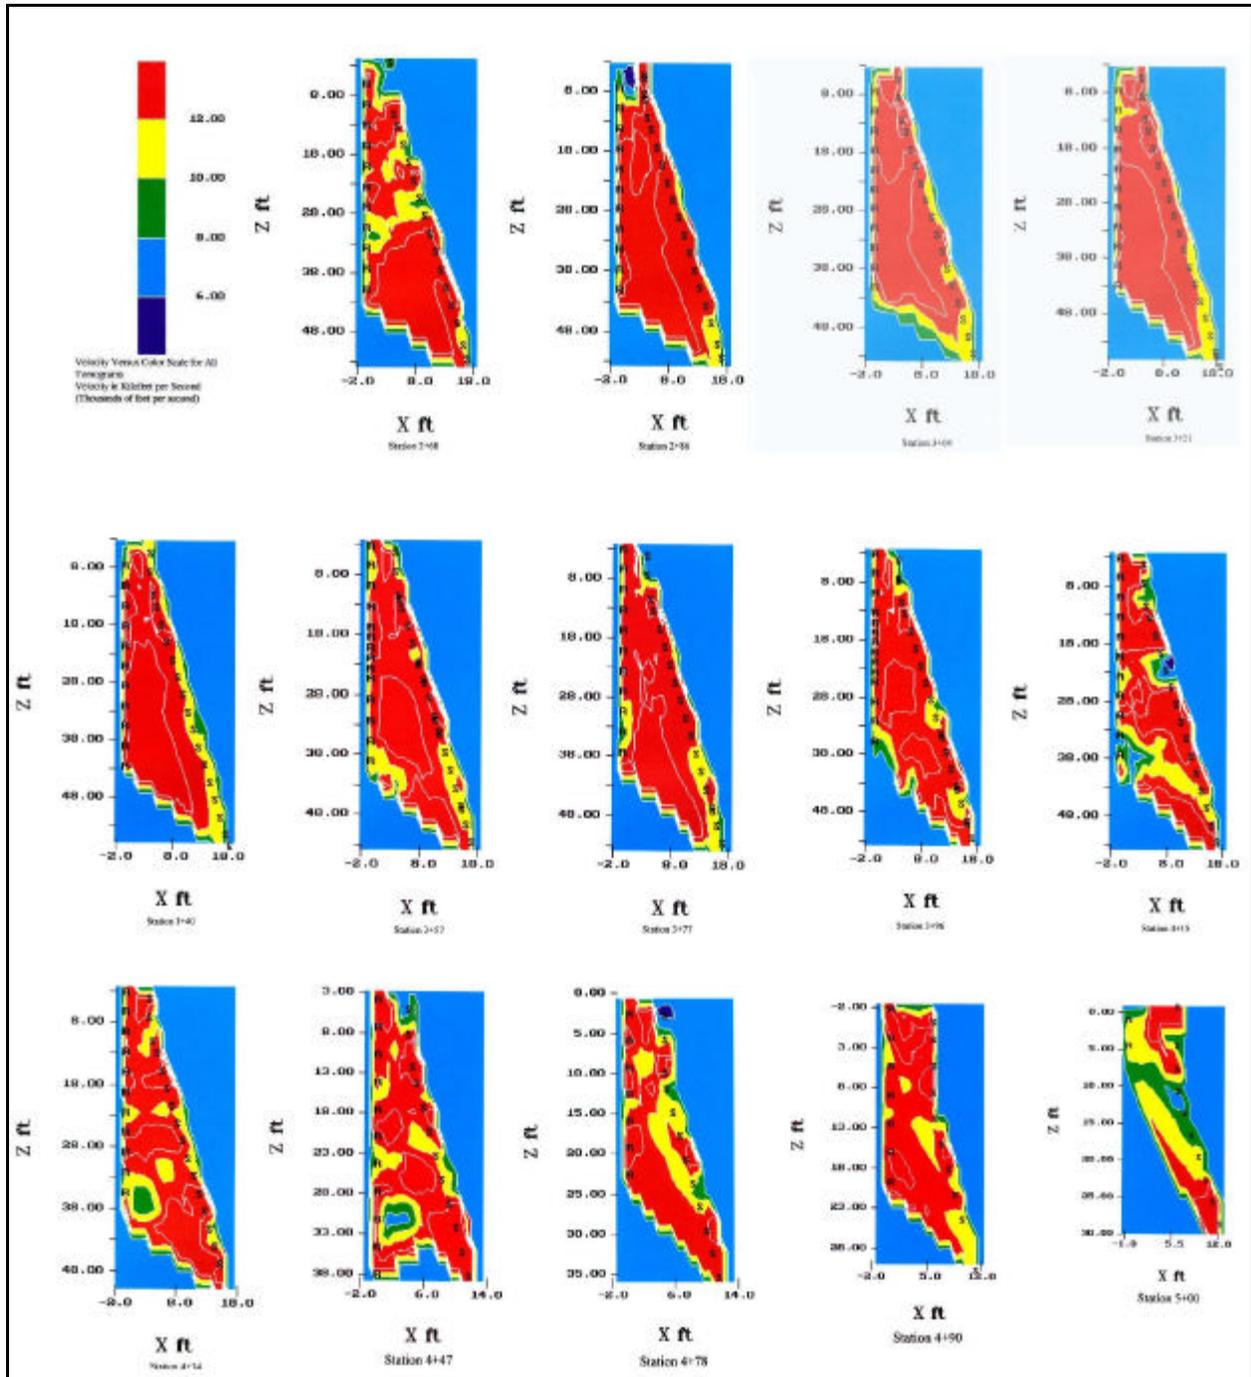
Stations 4+15, 4+34, and 4+47: A relatively large anomaly is present at about the same elevation (114.5 to 119.5 feet) at Stations 4+15 and 4+34. The anomaly at Station 4+47 is slightly higher in elevation but is similar in size and shape, suggesting a possible relationship between these anomalies. Station 4+15 shows another higher confidence anomaly at elevation 128.5 to 133.5 feet near the upstream face.

Figure 8. Tomograms for Stations 2+68 through 5+00
