# Fusion of NDE Scanning and Photogrammetric Data for Concrete Bridge Decks and Girders Condition Assessment

Larry D. OLSON<sup>1\*</sup>

<sup>1</sup> Olson Engineering, Inc.; Wheat Ridge, Colorado, USA

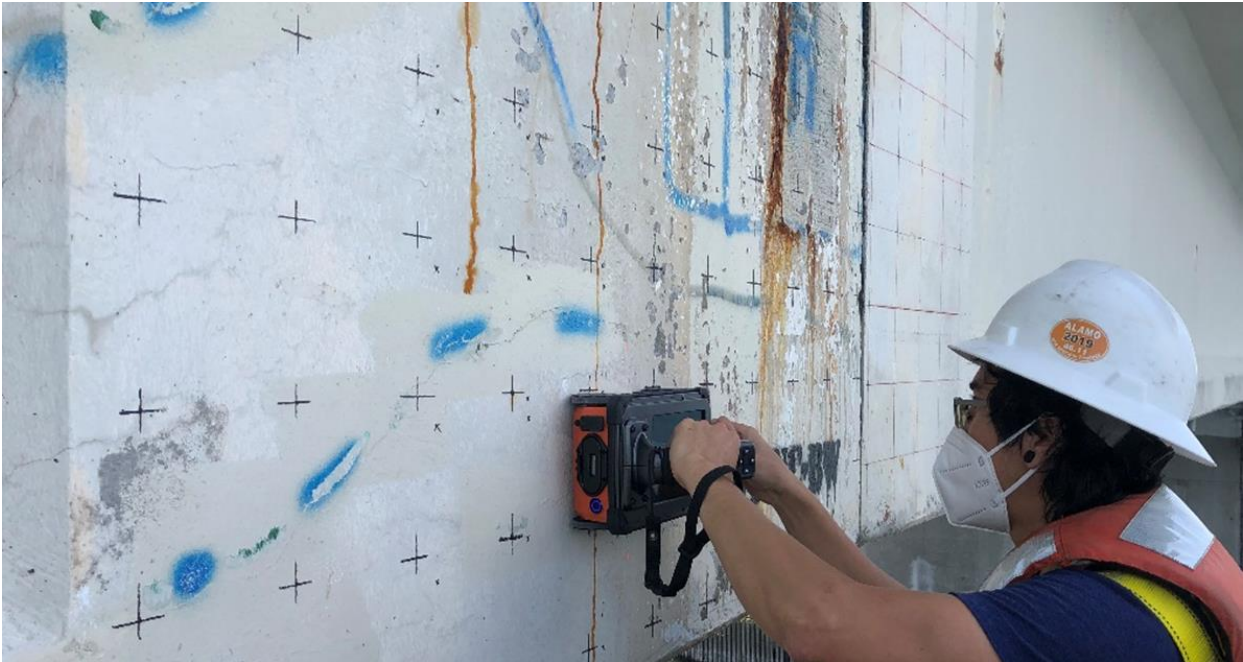
**Figure 3:** Horizontal GPR scanning on a 3 in (75 mm) grid (vertical scans were also completed) for 3-D GPR image

The GPR method involves moving an antenna across a test surface while periodically pulsing the antenna and recording the received echoes (Fig. 2). A handheld GPR unit was used to scan the girder webs and ends both vertically and horizontally (Fig. 3) in order to produce 3-D images

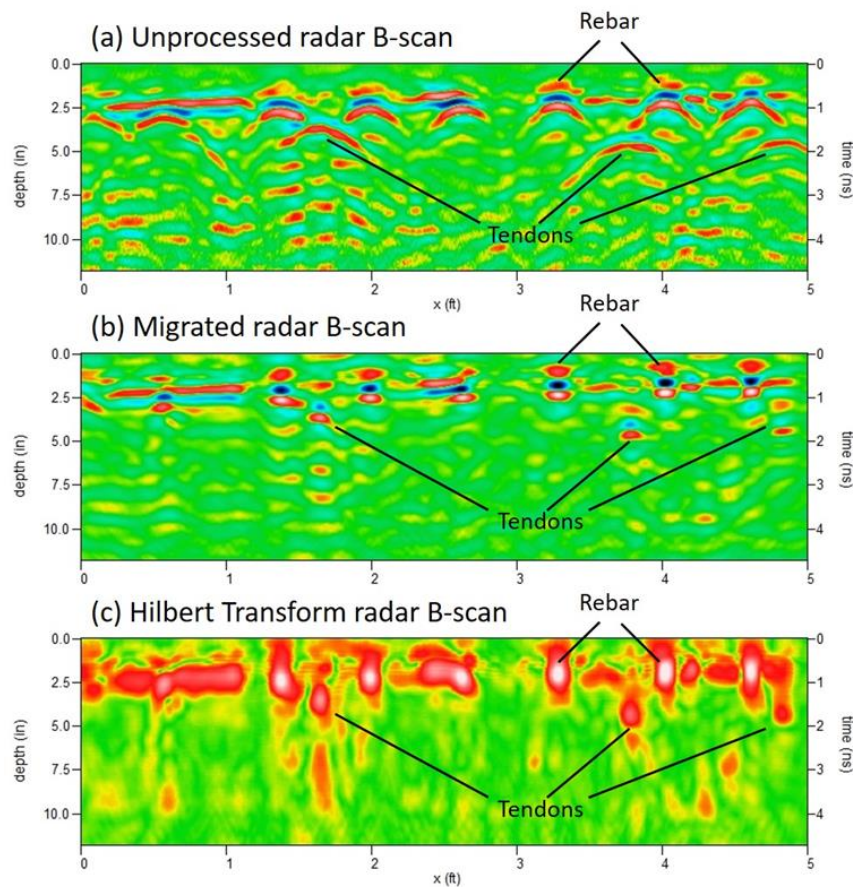
**Figure 4:** 2-D GPR vertical scan data analyses steps before combining into 3-D GPR image

The raw GPR data from a vertical 2-D straight scan line is presented in Figure 4(a) with the hyperbolic-shaped reflections at a 2 in (50 mm) concrete cover depth indicating the near-surface horizontal rebar. Note the post-tensioned metal tendon ducts are larger in diameter and have broader and deeper hyperbolic reflections at 3 to 4 in (75 to 100 mm) deep. The GPR data is then migrated to collapse the rebar and duct reflections to a dot shape as shown in Figure 4(b). The final step is a Hilbert Transform that further clarifies the depths and locations of the rebars as the pulses are merged into a single pulse envelope as shown in Figure 4(c). The horizontal and vertical processed 2-D GPR scans were then combined to produce the 3-D GPR image that is overlaid on the photogrammetric image (Fig. 5). Review of this figure reveals the locations of embedded rebar, tendon ducts and metal plates overlaid on the photogrammetric image in Figure 1.

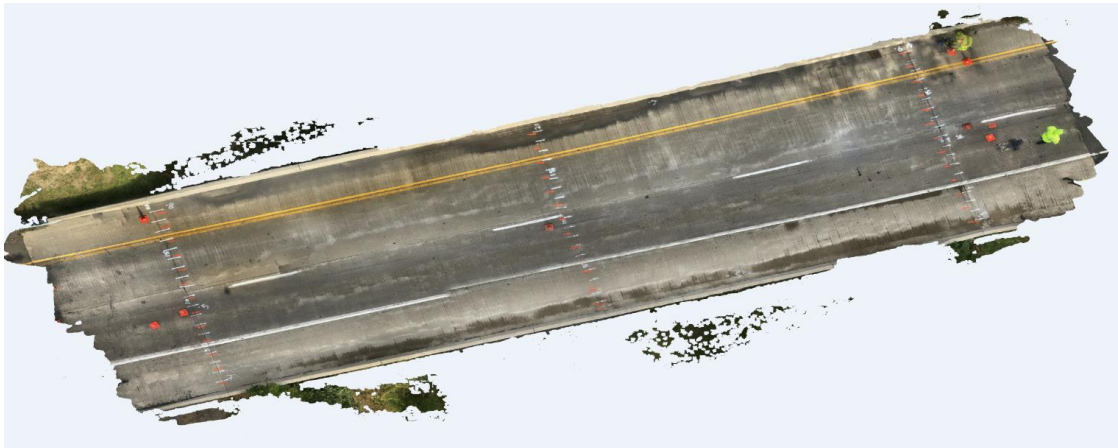
**Figure 13.** Digital orthomosaic (photogrammetric image) of concrete bridge deck

The photogrammetry approach is described above in Section 2.1. The process is the same for bridge girders and bridge decks. A photogrammetric image of the bridge deck is presented in Figure 13 below.

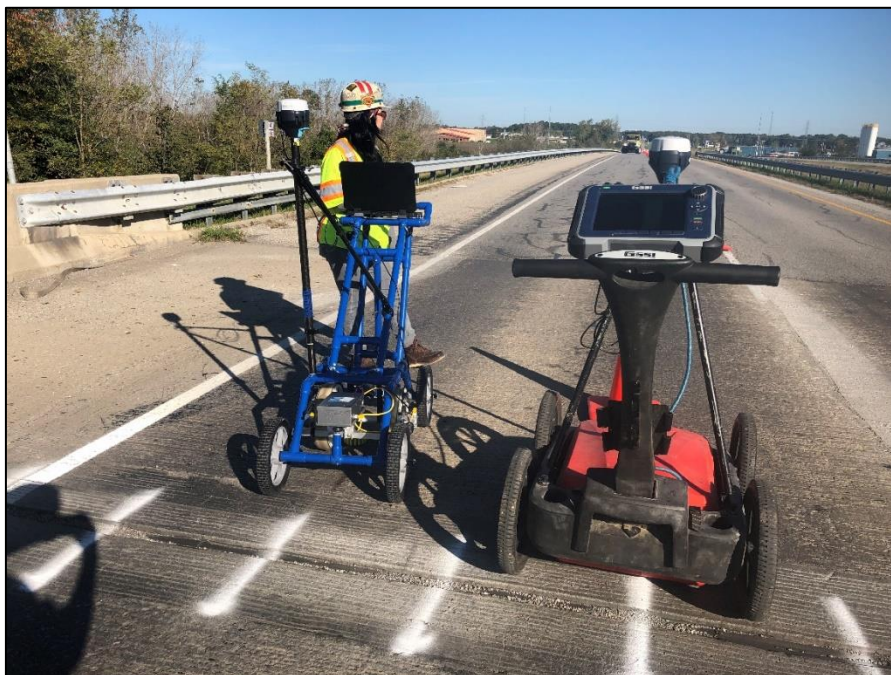
**Figure 14:** Photograph of Olson Sonic Surface Scanner – Impact Echo system (left) and of the GSSI SIR-4000 computer and a 1600 MHz GPR antenna (right) placed in a hand push-cart for ground coupling. Note GPS unit antennas (white) sticking up above each cart

The GPR in this study utilized a cart that was rolled along longitudinal scans lines at the same 1-foot transverse spacing across the entire bridge (same configuration as SSS-IE discussed below – both systems configured with integrated RTK GPS systems for centimeters-accurate location data). The GPR and SSS-IE systems are shown side-by-side in Figure 14. The GPR data were used to develop a detailed 2-D steel reinforcement concrete cover map to be constructed. Figure 15 presents an example raw GPR data scan from the bridge deck showing the transverse steel reinforcing bars denoted with a red dot. Figure 16 presents the resulting interpolated concrete cover map overlaid on photogrammetric image.

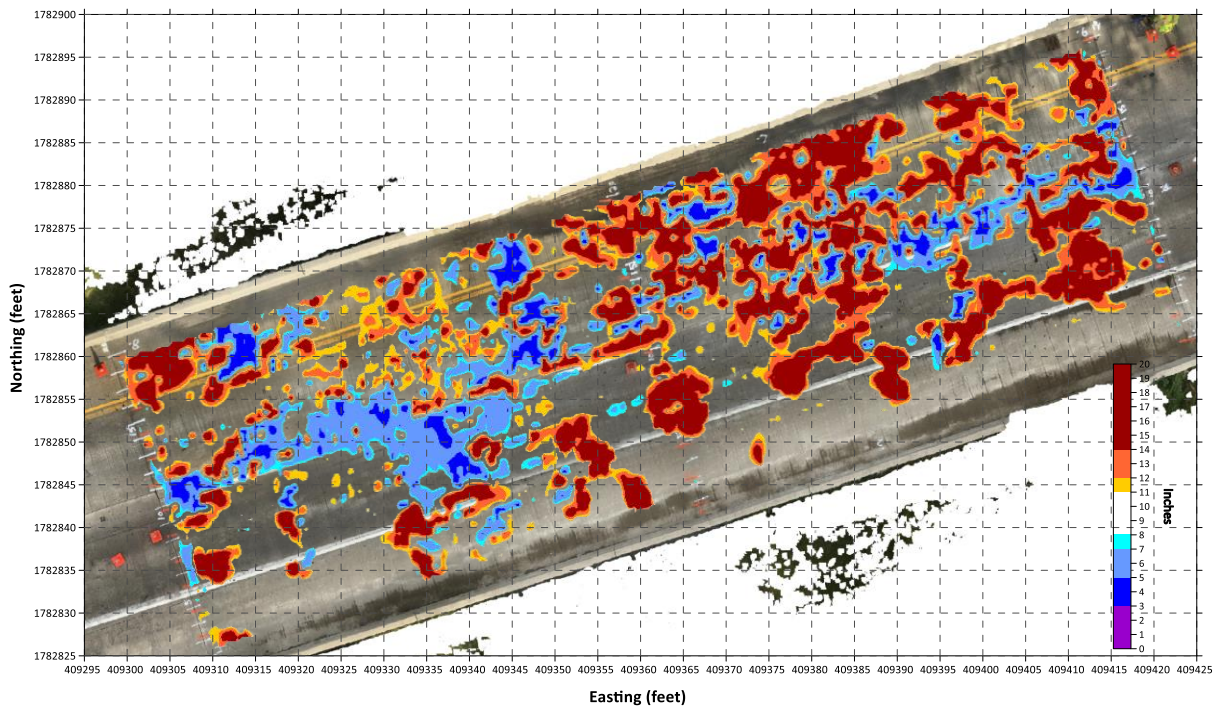
**Figure 19.** SSS-IE Interpolated Condition Map (presented as thickness echo depths – see legend on right) with photogrammetry underlay.

The SSS-IE method uses the same IES method discussed in Section 2.3, but with an Olson Instruments Sonic Surface Scanner that performs an IE test on two scan lines every 6 inches as the unit is rolled along the bridge deck at a rate of approximately 1.0 mph (1.6 km/h). A close-up view of this system is presented in Figure 18. Scan lines were spaced 1 foot (0.3 m) apart across the entire width of the bridge, along the same lines as the GPR discussed above. For bridge deck studies, results are typically presented based upon the thickness of the resulting resonant echo. If near-surface delaminations within the concrete slab are present in typically the top 3 inches of the concrete, the delaminated concrete responds with a low-frequency, undamped flexural resonance response which counter-intuitively appears much thicker than the expected deck thickness and corresponds to the hollow, drummy sound associated with acoustic sounding. The actual depth of such a delamination is not determinable from the data but is generally assumed to be at the depth of the deck top-steel or the interface of an overlay. If the concrete is sound near the surface but has other deeper internal horizontal cracking, then an echo resonance is measured that corresponds to the depth of that internal cracking, which may be delaminations due to deep top steel, or could be delaminations at the bottom of the deck due to corrosion of bottom steel. If no damage is present, the IE tests exhibit sharp and consistent resonant echo frequencies that correspond to the concrete deck thickness at that test point. An example of this data is presented in Figure 19. A map of the SSS-IE results is presented in Figure 20.
