1 **Bridge Deck Scanning for Condition Assessment**
2 **of Bare Concrete and Asphalt Overlaid Decks**

44 **ABSTRACT**

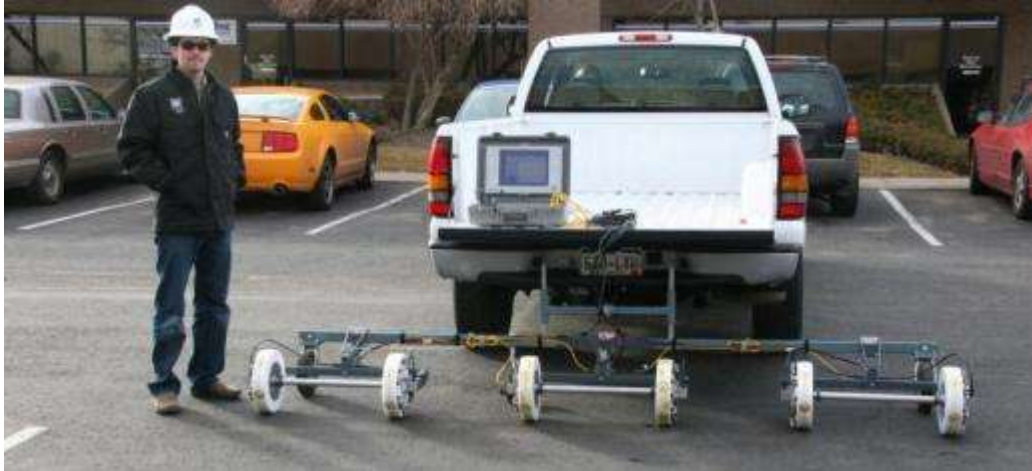
Figure 2 – Bridge Deck Scanner Towed behind a Vehicle – 3 pairs of wheels at 2 feet (0.61 meter) apart

The two transducer wheels are identical. The BDS system can be equipped with up to three pairs of transducer wheels and can be easily attached to either a vehicle hitch (if all three pairs of transducer wheels are used) as shown in Figure 2 or a scanning cart (if only a pair of transducer wheels are used) as shown in Figure 3. Each set of transducer wheels of the BDS system can perform:

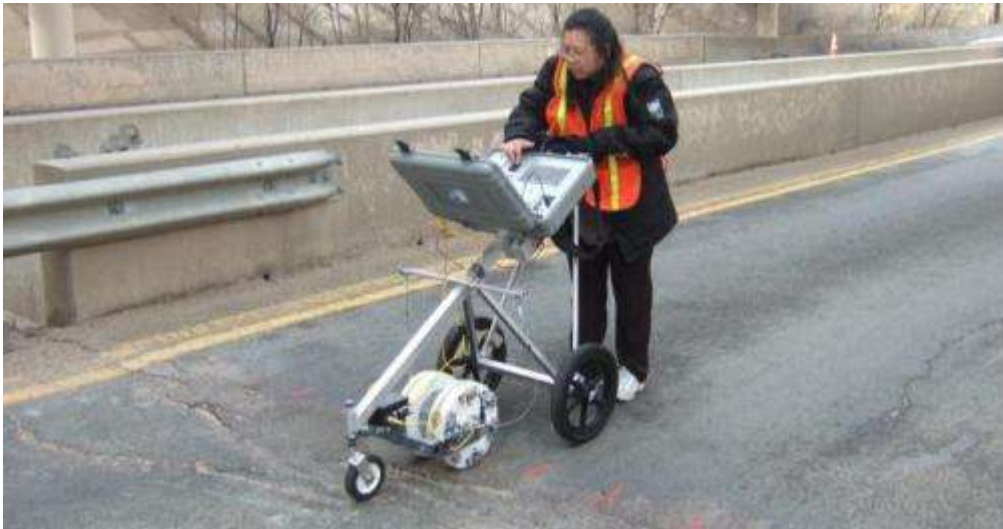
Figure 3 – BDS System Attached to a Scanning Cart on Asphalt Overlaid Deck – Single Pair of Wheels at 6 inches apart for Combined Impact Echo/Surface Waves Scanning

- 2) Impact Echo and Spectral Analysis of Surface Waves (SASW) scanning simultaneously by aligning the transducer elements of both transducer wheels. The first transducer wheel (with the impactors on) can be used to perform the Impact Echo test. The second wheel (with the impactors off) can be used as the second transducer to acquire data for the SASW test analysis. Note that both Impact Echo and Spectral Analysis of Surface Waves tests can be performed simultaneously in a single scan. This setup provides additional information for complex situations such as assessment of a concrete deck under an asphalt overlay, which, in past experience, has been problematic for IE testing alone.

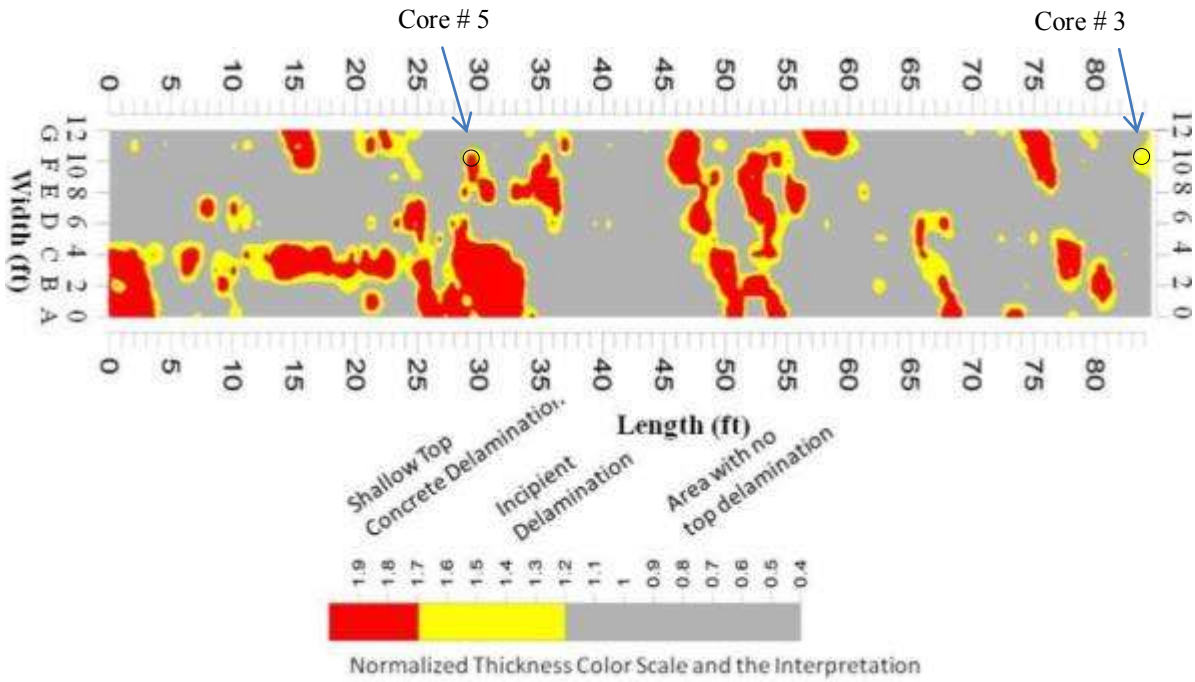
Figure 5 – Top Concrete Delamination Map from the BDS System – Impact Echo Scanning

224
 225 The graphical IES test results from the Bridge Deck Scanner are presented in Figure 5. The
 226 thickness results from the IES tests were normalized by the nominal thickness of the tested line.
 227 A global normalization could not be applied because the thicknesses of the concrete deck along
 228 the C and D Test Lines (5 feet (1.52 meters) and 6 feet (1.83 meters) east of Line A) were thicker
 229 than the design thickness of 8.5 inches (215.9 mm). It is assumed that this area was thickened to

230 provide additional bearing support, as this was at a location of one of the supporting steel girders.
231 The plot is a normalized surface thickness tomogram to illustrate the general condition of the
232 tested concrete deck. The majority of the indicated anomalies are predominantly top
233 delaminations (presented in red) based on the IES results. The gray color represents areas in
234 which the normalized thickness results were less than or equal to a value of 1.2, which are
235 indicative of “sound concrete”. Yellow represents areas with normalized thickness of 1.2 to 1.7,
236 or areas with incipient concrete delaminations. The quantity of areas with incipient
237 delaminations (plotted in yellow) detected from the BDS was estimated to be 135 sq ft (12.5 sq
238 meter) or 13.5% of the tested deck surface area. Areas with incipient delaminations and
239 delaminations deeper than 3-4 inches or 75 to 100 mm are not likely to be audibly detected by

240 human ears using chain drags for acoustic sounding (very subjective and dependent on chain
241 drag operators). Areas where the normalized thickness is greater than 1.7 are plotted in red,
242 which represents areas with probable top shallow concrete delaminations. These top
243 delaminated areas are likely detectable by human ears using acoustic sounding as a hollow,
244 drummy sound versus a high frequency sound from undamaged, good quality concrete. The
245 quantity of probable delaminations (plotted in red) detected from the BDS was estimated to be
246 149 sq ft (13.8 sq meter) or 14.6% of the tested deck surface area. The quantity of both
247 probable delaminations and incipient delaminations (plotted in yellow and red) detected from the
248 BDS was estimated to be 285 sq ft (26.5 sq meter) or 28.1% of the tested deck surface area.
249 Approximate data analysis of the IES data was 4 hours and 2 – 4 additional hours were required

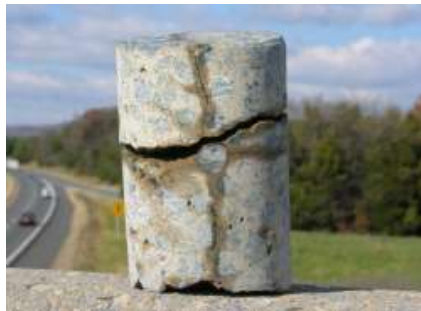
Core # 5 - Delamination Depth at 2.5 inches

Figure 7 – Photographs of Cores # 5 and #3 (Courtesy of Rutgers University)

254 For comparison purposes, Rutgers University performed acoustic sounding using chain dragging
255 and hammer sounding to listen to the hollow sounds from shallow top delaminations of the
256 concrete deck. The delamination map from chain drags is presented in Figure 6. In addition,
257 eight cores were taken from the deck. The delamination map from the BDS-IES component
258 agreed well with the visual observations of the eight cores. Photographs of two (of eight) cores
259 are shown in Figure 7. Review of Figure 7 indicates that the test results from the BDS-IES
260 component correctly identified both shallow (Core # 5) and deeper delaminations (Core # 3),
261 where-as chain dragging only correctly identified shallow delaminations (Core # 5 - 2.5 inches or
262 63.5 mm deep) and failed to identify deeper delamination (Core # 3 – 3.5 inches or 88.9 mm
263 deep).

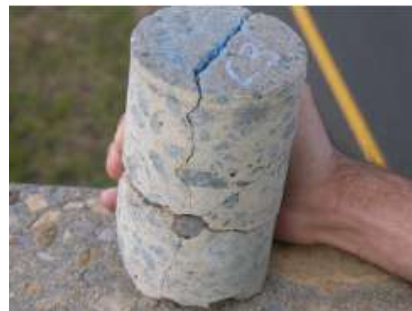
Core # 3 - Delamination Depth at 3.5 inches

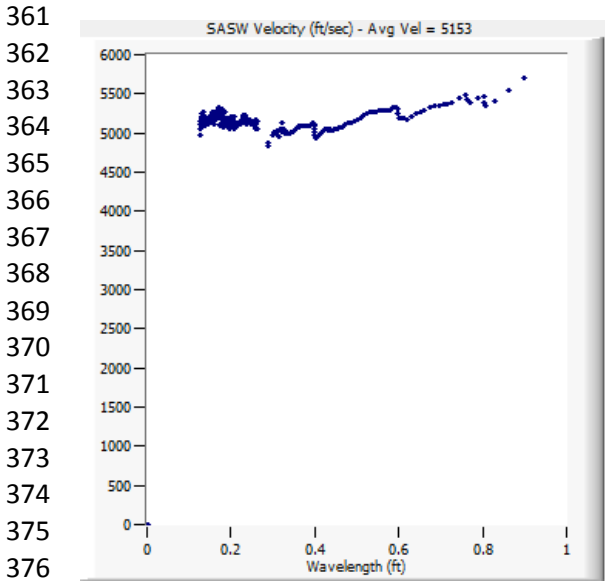
377 Figure 8a – Sound Concrete

339 Figures 8a – 8d present example SASW test records and the corresponding data interpretations
340 from the asphalt overlaid deck. The plot shows the dispersion curve presenting the surface wave
341 velocity vs wavelength (or depth in the deck). Sound concrete (with no asphalt debonding)
342 yields a high and relatively constant surface wave velocity shown as a flat and horizontal line in
343 a dispersion curve throughout the depth of the bridge deck. A typical example of this case is
344 shown in Figure 8a. Olson Engineering has found that the presence of a sharp drop in the surface
345 wave velocity within the dispersion curve acts as a reliable indication of either potential
346 debonding between the asphalt (and between layers of asphalt pavements) and concrete and/or
347 delamination within the concrete layer. The location (wavelength) of the velocity drop relates to
348 the depth of either the debonding or delamination. This sudden drop of surface wave velocity is

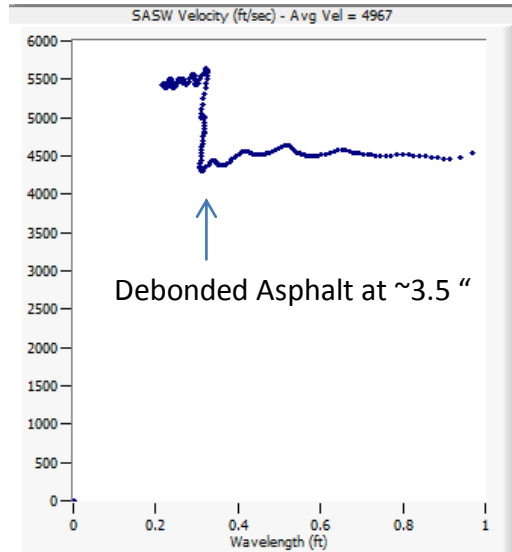
377 Figure 8b- Debonded Asphalt on Sound Concrete

349 then automatically detected by the BDS software to locate the depth of discontinuity (either
350 asphalt debonding or concrete delamination). The depth of the detected discontinuity is then
351 used to determine if discontinuity is in the asphalt layer, between the asphalt and concrete or
352 within the concrete layer. Figure 8b presents a dispersion curve (surface wave velocity vs
353 wavelength) from a location with possible asphalt debonding where a velocity drop is located at
354 a depth of 3.5 inches (88.9 mm) from the surface. Figure 8c presents a dispersion curve from a
355 location with apparently both asphalt debonding and bottom concrete delamination where two
velocity drops are detected at 3.2 inches (81.3 mm) and 7.4 inches (187.9 mm) from the surface.

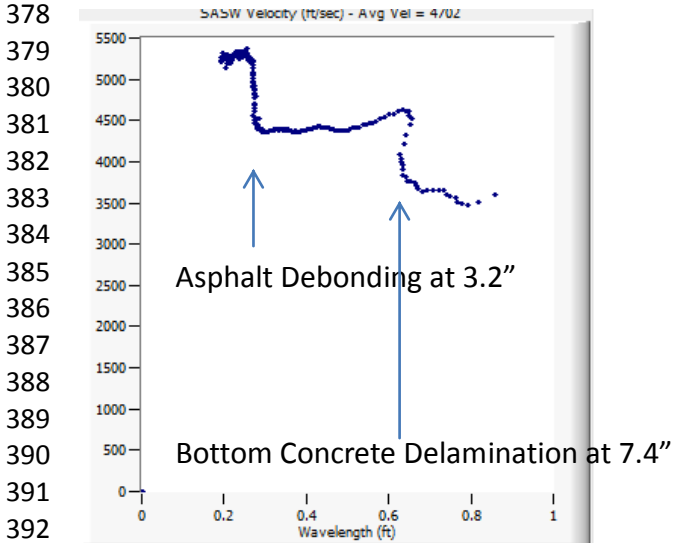
394 Figure 8c – Debonded Asphalt on Concrete
 395 With Bottom Delamination

357 Note that the destructive verification of bottom delamination conditions were not performed due
 358 to safety concerns during coring. Figure 8d presents dispersion curves from locations with
 359 apparent top concrete delaminations where the depths (wavelengths) of the velocity drops are
 360 indicative of the top reinforcement depths.

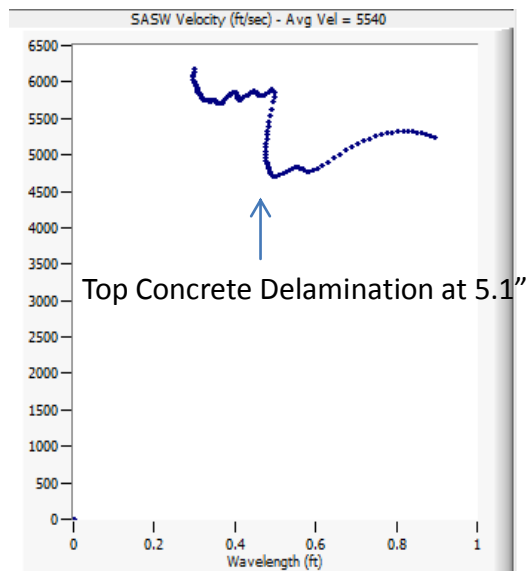
394 Figure 8d – Top Concrete Delamination
