3 **Keywords:** Nondestructive Testing, Ground Penetrating Radar, Impact Echo, Ultrasonic  
4 Tomography, Ultrasonic Echo, Bridge Inspection

16 In order to simulate a realistic geometry, reinforcement details, and accessibility conditions, a full-  
17 scale 22.9 m long, 4.2 m wide, and 1.85 m deep post-tensioned U-girder specimen was constructed.  
18 To evaluate the effectiveness of the various NDE techniques in detecting grout defects in the  
19 internal tendons, several parameters such as tendon diameter, concrete cover, tendon profiles, duct  
20 material (corrugated metal or non-metal), reinforcement surrounding the tendon, and layered  
21 tendons were incorporated into the specimen. Fig. 1 shows the general layout of the tendons and  
22 the tendon designation. Corrugated plastic ducts were used for Tendons 1 and 2 (internal diameter  
23 (ID) = 76 mm, outer diameter (OD) = 91 mm, thickness (T) = 2.5 mm) in the flange of the South

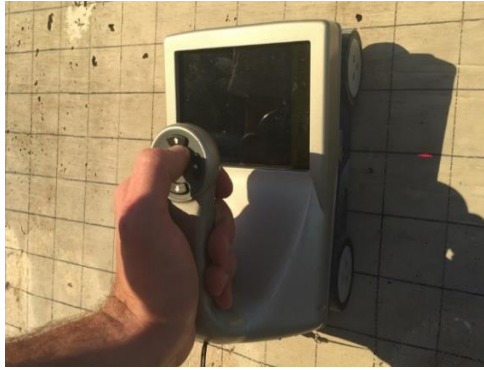
(a) StructureScan Mini HR GPR unit

19 The GPR inspection technique was used to inspect grout defects in the internal tendons in the  
20 walls, flanges, and anchorage regions of the PT girder specimen. Geophysical Survey Systems,  
21 Inc. (GSSI) StructureScan Mini HR high-resolution GPR system with a 2.6 GHz antenna, which  
22 has a scan depth of 400 mm, was chosen for this application. Fig. 3(a) shows the StructureScan

1 Mini HR GPR unit mounted on wheels. The device records data as the unit is rolled along the  
2 inspection surface. A 50 mm × 50 mm grid system was created on the webs, flanges, and anchorage  
3 regions of the PT girder specimen. GPR scans were made along the grid system in both the x-  
4 direction (along the length of the specimen) and y-direction (transverse to the length of the  
5 specimen) to generate a 3D model of the inspected specimen.

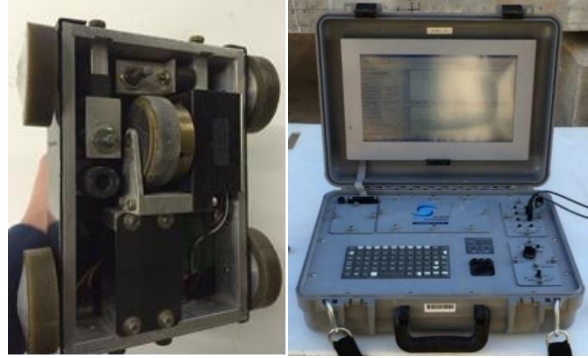
(b) IE scanner and DAQ PC

22 The Impact Echo tests were performed using an IE scanner test head that was connected to a data  
23 acquisition (DAQ) system. Fig. 3(b) shows the photo of the impact echo scanner mounted on

1 wheels and the DAQ system. The IE scanner produces an impact at 25 mm intervals as it is rolled  
2 along the concrete surface. To assess the grout defects within internal tendons of the PT girder  
3 specimen, scans were performed along vertical lines at 152 mm spacing along the entire length of  
4 the webs of the North and South Wall. In addition, GPR scans were performed vertically on both  
5 the webs at 762 mm nominal spacing to determine the locations of internal PT tendons.

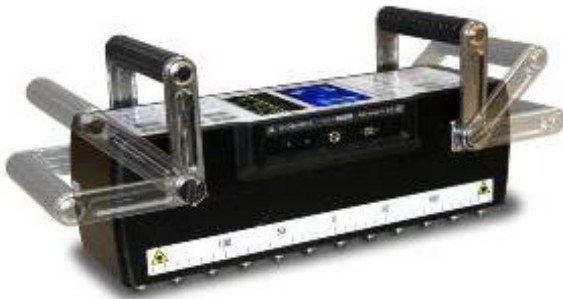
(c) UST inspection using A1040 MIRA ultrasonic tomograph

8           An ultrasonic tomograph A1040 MIRA system was utilized to identify grout defects in the internal  
9 tendons embedded in the webs, flanges, and anchorage regions of the PT girder specimen. Fig. 3(c)  
10 shows the MIRA device used for scanning the specimen, which is capable of testing concrete  
11 thicknesses up to two meters. The measuring device consists of a  $4 \times 12$  array of dry contact low  
12 frequency transducers that transmit transverse waves with a nominal operating frequency of 50  
13 kHz. When the device is triggered, a column of four transducers act as the transmitter, whereas the  
14 remaining columns of transducers act as receivers. The device creates a data array using the  
15 information measured from the transducers. The built-in processor allows onsite data analysis and  
16 displays an image on the built-in screen. A special purpose software can be used to create a 3D

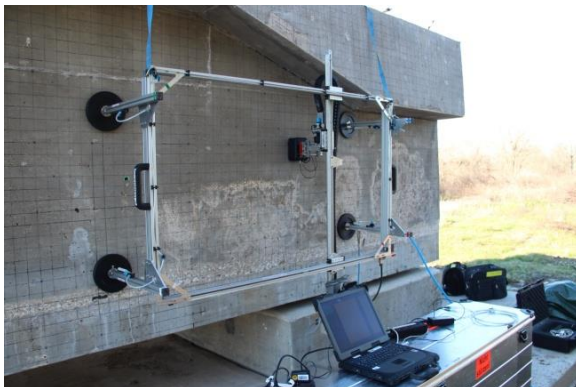
(d) USE inspection with dual element probe mounted on an automated scanner

13 The ultrasonic echo device used in this investigation consists of a control unit and a probe.  
14 The control unit generates an electronic pulse of several hundred volts. This impulse is led to the  
15 probe through a coaxial cable. The probes are excited using the piezoelectric pulse principle. The  
16 probe is made up of 24 dry point transducers that are mounted on a spring mechanism, and does  
17 not require any coupling agents. The spring mechanism ensures contact even on rough concrete  
18 surfaces. A total of 12 transducers act as transmitters, whereas the remaining 12 transducers serve  
19 as receivers.

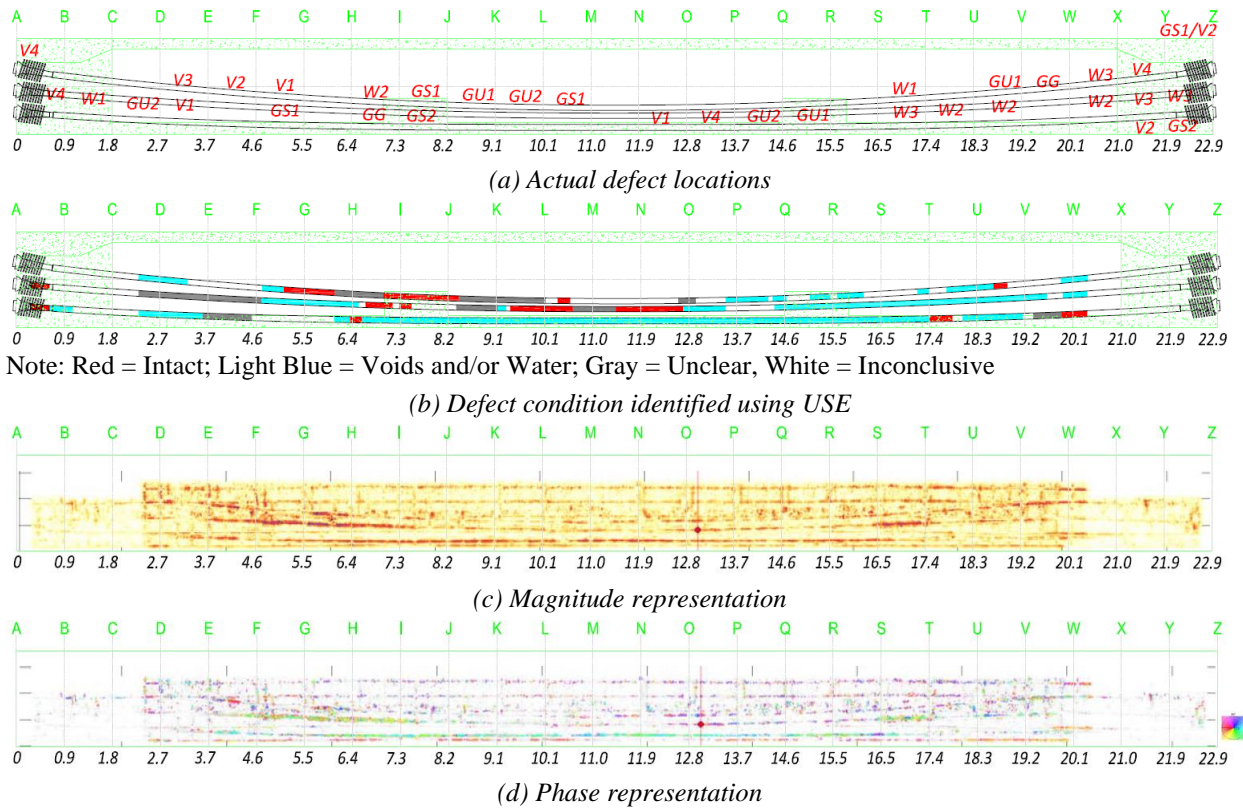
1  
 2 Fig. 8–Comparison of USE scan results with defect key – exterior North Wall of PT girder  
 3 specimen.

12 Fig. 8 and Fig. 9 present the results from USE inspection of the North Wall and South Wall,  
13 respectively, and a comparison of the scan results with the actual defect conditions. While Fig. 8(b)  
14 and Fig. 9(b) represent the overview of the phase analysis results, thereby simplifying the  
15 comparison of the scan results with the defect key, figures (c) and (d) presents the amplitude and  
16 phase diagrams in false color representations. The spatial resolution of the result is about 200 mm,  
17 implying that deviations of the phase value smaller than 200 mm may not be indicated in the  
18 results. The results are classified and indicated in three colors: (a) red corresponds to high  
19 impedance, about a 180 degree phase shift, which implies an intact tendon; (b) blue corresponds  
20 to low impedance, about a 0 degree phase shift, which implies air voids and/or water; (c) gray  
21 indicates an unclear result; and (d) white represents no or very weak phase indications. For air

1           Although the USE technique was more effective than the IE method in terms of identifying  
2 the location of grout defects, it still did not provide conclusive results that could be used for  
3 inspection of internal tendons. The USE method could successfully identify the location of two-  
4 thirds of the water infiltration defects and one-third of the voids and compromised grout in internal  
5 tendons. This technique does not give any information about the severity of the grout defects. In  
6 addition, the location of intact sections could not be detected conclusively [38, 39].
