SONIC PULSE VELOCITY TESTING TO ASSESS CONDITION OF A CONCRETE DAM

*Edward D. Billington, AG&E-Schnabel, Greensboro, NC
Dennis A. Sack and Larry D. Olson, Olson Engineering Inc., Wheat Ridge, CO*

Abstract

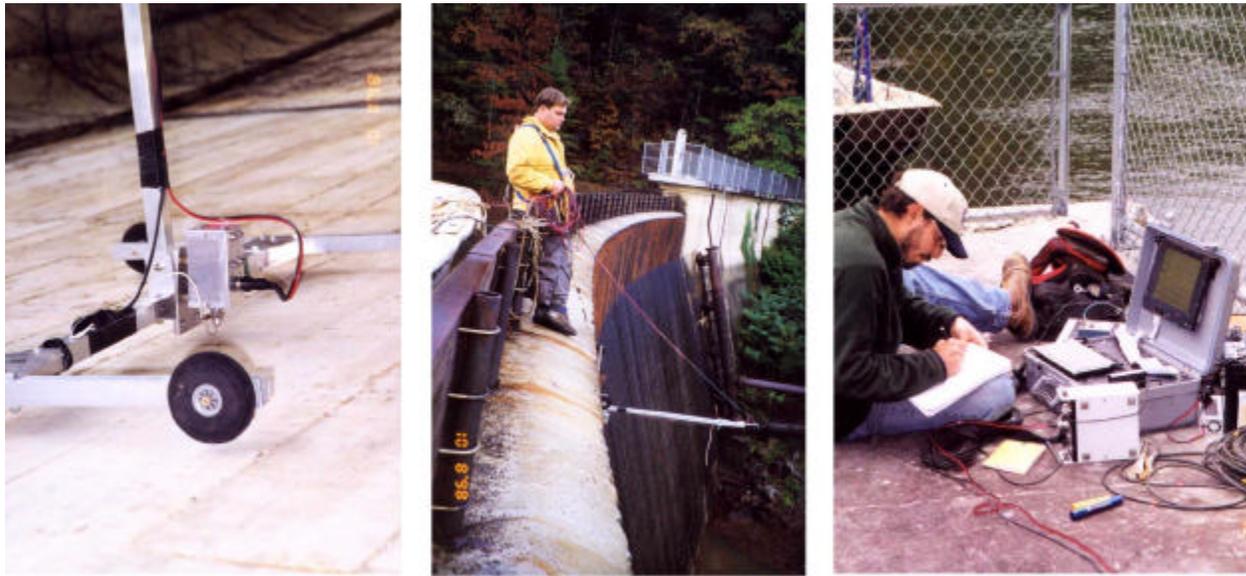
Figure 2. Photographs from October 1998 data acquisition. From left: Closeup of solenoid-actuated sonic impact source; lowering source from top of dam; recording data at station near left abutment. For most stations, the recording unit was in a boat.

Problems encountered during the field work included difficulty in obtaining a sufficient signal at some locations due to buildup on the downstream dam face. In these instances, the impact source was moved slightly up or down the dam face, or slightly to either side, until a signal of sufficient amplitude was obtained. The intakes for the fish hatchery on the left side of the dam were open during the test, causing some background noise that reduced the confidence level of the first arrivals for records obtained close to the intakes.

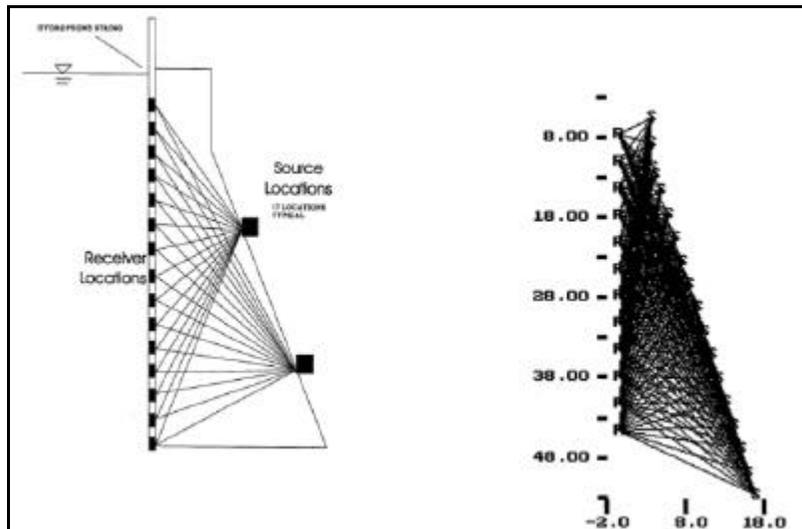
The compressional and shear wave energy transmitted through the dam were recorded using a string of seven hydrophones held vertically against the upstream face of the dam (Figure 3). The hydrophone spacing was one meter (3.28 feet) for a total length of six meters (19.8 feet). The water depth was measured at each station to determine the number of vertical hydrophone locations necessary to get full coverage. In most cases, the hydrophone string was lowered vertically for additional tests to provide full coverage of the upstream face of the dam. The source locations were repeated for each hydrophone string location. The use of a multiple channel hydrophone string and repeated source locations provided up to 220 raypaths and velocity measurements per station. A typical plot of raypath density is shown in Figure 3. The number of raypaths was less for the shallower areas nearer to the abutments.

Figure 3. Schematic raypath geometry (on left) and raypath density plot for typical station.

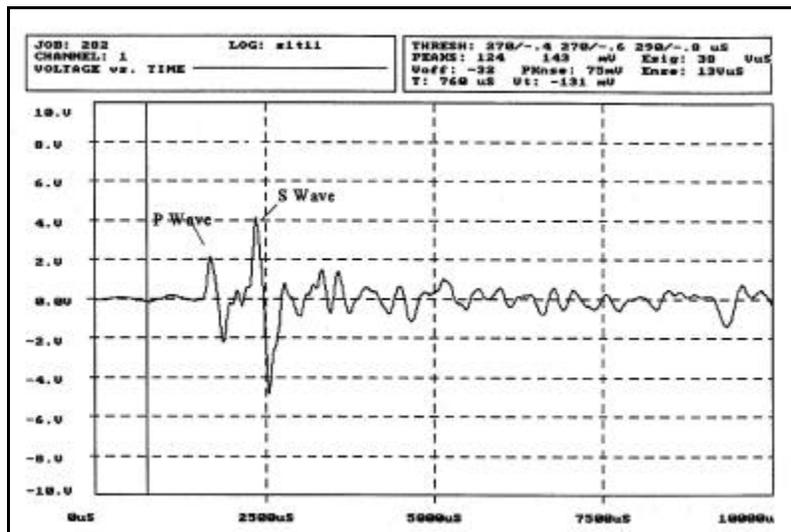
The data were recorded digitally for each measurement location. The first arrival of the compressional wave at each hydrophone was picked manually (Figure 4). In some cases, the first arrival of the shear wave energy was used where the data was too noisy to pick the first arrival of the compressional wave (Figure 5). Prior to running the tomograms, the shear wave arrival times were converted to the equivalent compressional arrival times using an empirically derived constant (Poisson's Ratio).

Figure 4. Example trace showing P-wave and S-wave arrivals through dam. Note high signal-to-noise ratio.

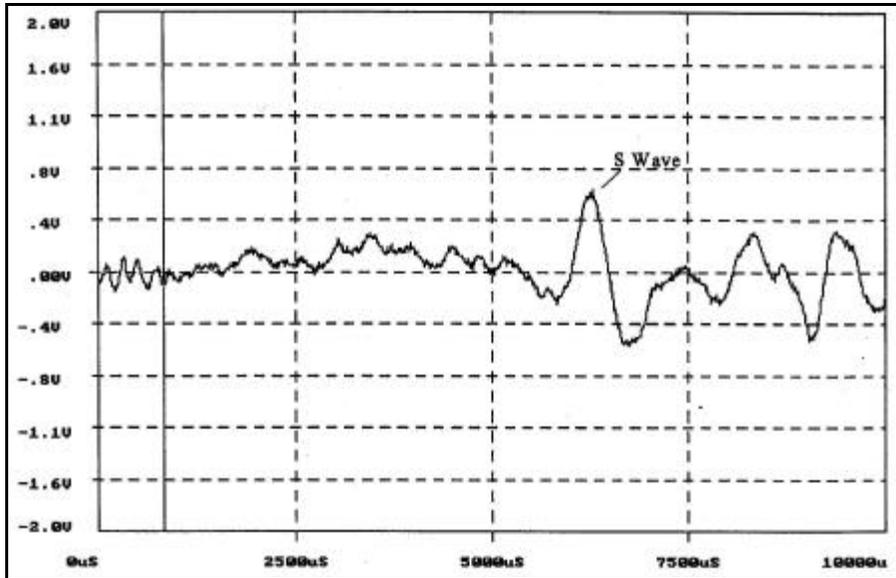
Figure 5. Example data trace showing low signal-to-noise ratio and no clear P-wave arrival. Note the strong S-wave arrival that was used in these instances.
